## Repair instruction

Description: Thermocouple V1

Part number: 623020

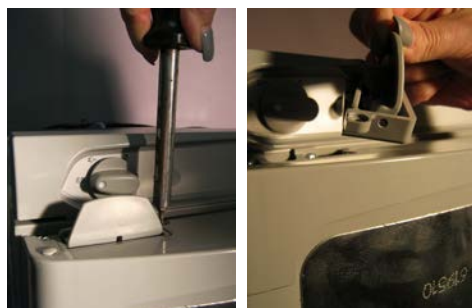
**A**

Remove 2 screws and replace latch.

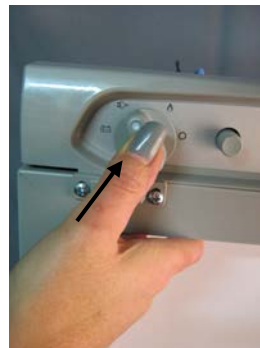
Pull knob from axle.

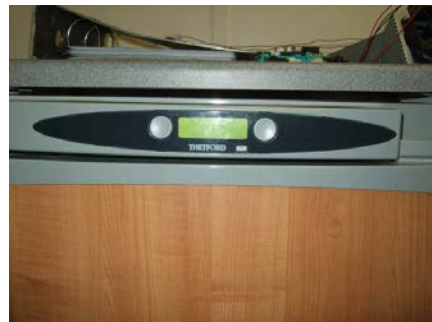
**A**

When exchanging the Display Board there is no need to remove the fridge however we do advise to isolate the fridge from the mains and 12v supply

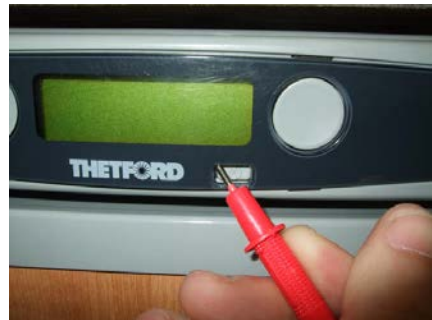
**B**

Remove the oval perspex display by using a small flat screwdriver. Push the screwdriver behind the on/off button and pull forward

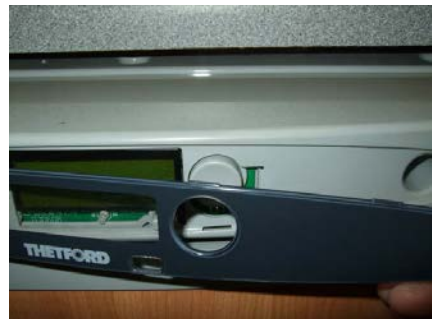
**C**

Once the first couple of clips have been released the overlay simply pops out

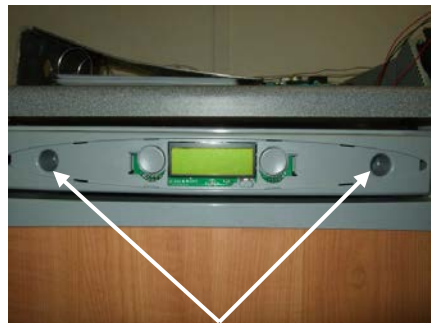
D

Now the overlay has been removed you will see two holes in the grey control board housing.

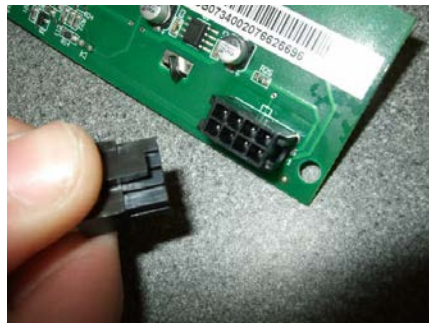
I

Unclip the white wiring loom from the display board by holding the black plug, this way the wiring loom shouldn't get damaged

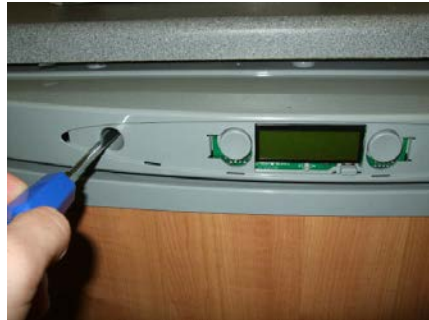
K

Replace the control board housing taking care as not to trap any of the wires before screwing it back in place

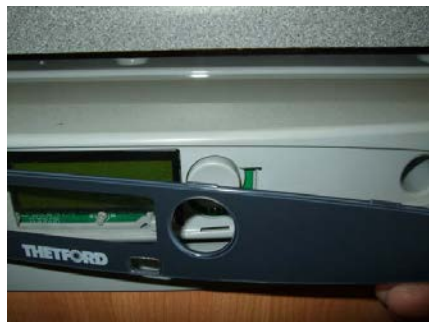
L

Re-attach the overlay by clipping back in place. The fridge can now be reconnected to the electricity supply and tested

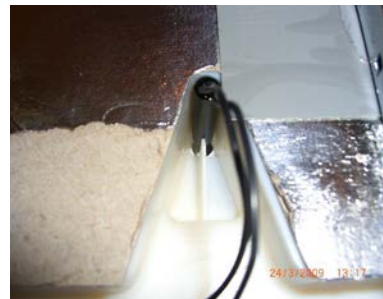
**C**

The reed switch is located at the right hand side and has 2 black wires going to it

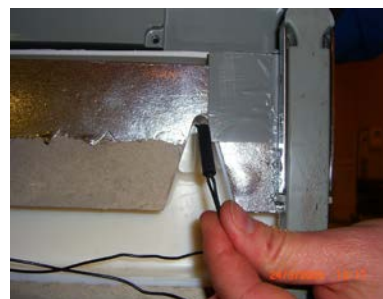
**D**

Simply unclip the existing faulty reed switch

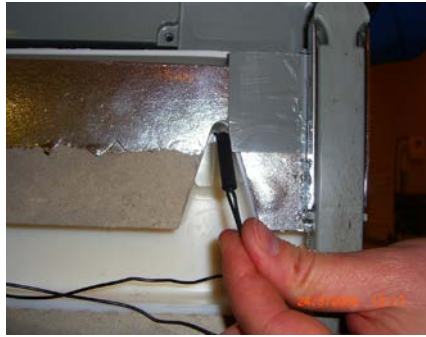
G

Once the new part has been reconnected to the wiring loom clip the reed switch back into place

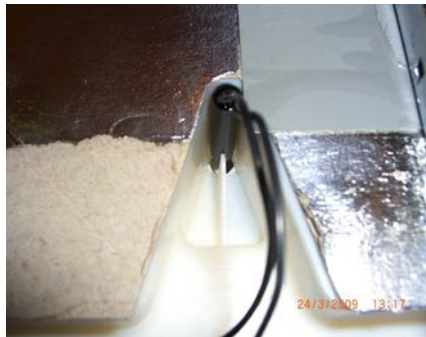
H

Once it is back in place ensure the reed switch is pushed up as far as it will go,

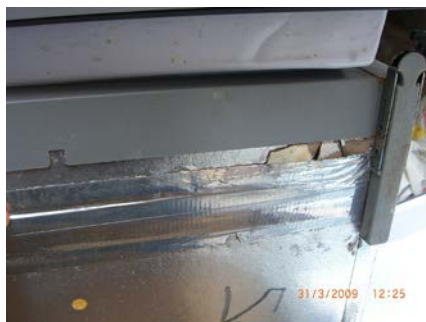
I

Replace all the wiring into the channel and tape the cardboard back in place before re-installing the fridge.

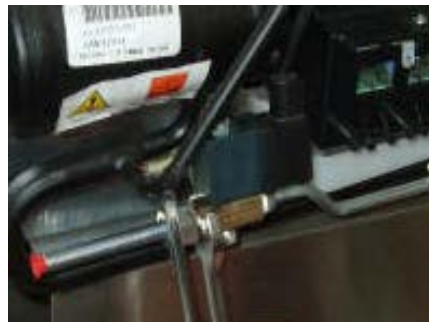
**B**

Start by loosening the gas inlet tube by turning the nut anti clockwise to the valve, making sure the valve is held firmly in place

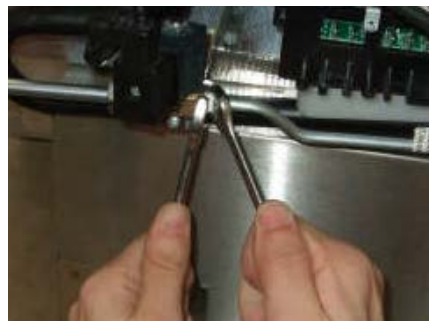
**C**

Secondly loosen the gas pipe to the burner again ensuring the gas valve cant move during disconnection

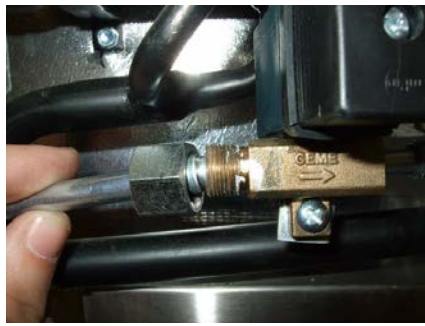
D

The gas inlet tube can now be removed from the gas valve

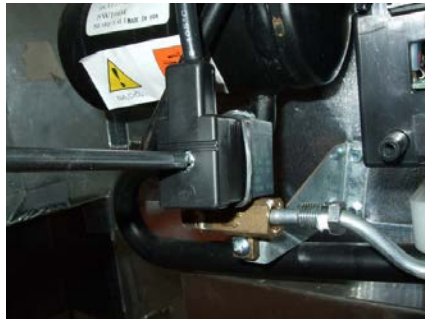
F

Remove the plug from the valve by undoing the screw on the front

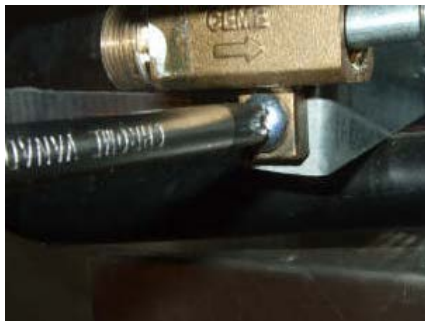
G

Remove the screw that holding the gas valve to the galvanized bracket

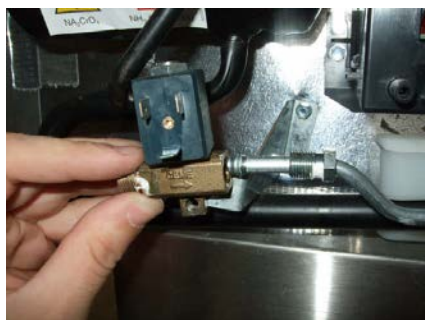
H

The gas valve can now be removed by sliding it away from the burner tube

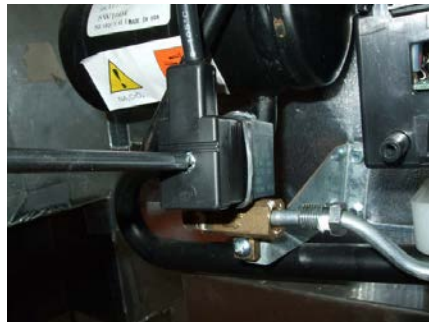
I

Attach the new valve to the burner pipe, screw it back to the galvenised bracket and re-attach the plug to the gas valve

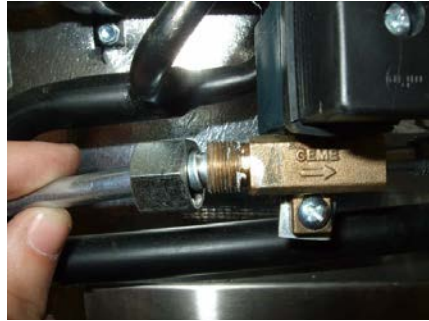
J

Fasten the inlet tube to the valve ensuring a secure sound connection. Using a 17mm spanner and a Torque setting of 20Nm +2/-0

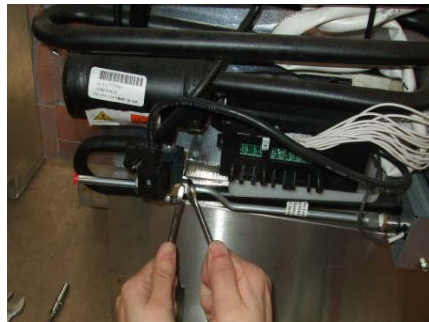
K

Tighten the nut that holds the burner pipe to the gas valve again ensuring a secure connection. Using a 11mm spanner and a Torque setting of 10Nm +0.5/-0

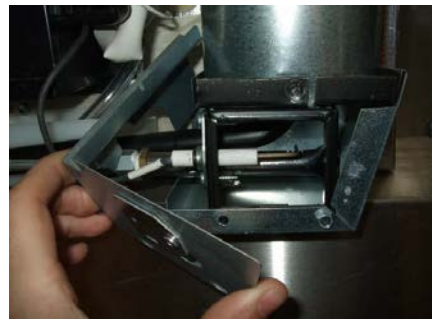
**C**

Remove the cover taking care not to damage electrode lead

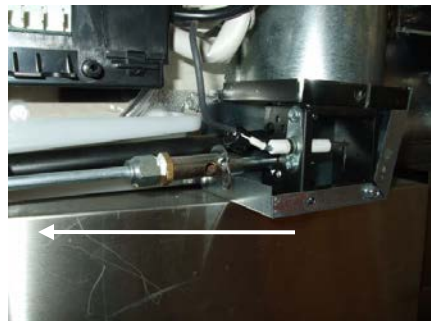
G

The whole assembly can now be removed by sliding the burner out of the burner box housing
