## Repair instruction

**Description:** C2 C3 C4 Vent seal

**Part number:** 20339

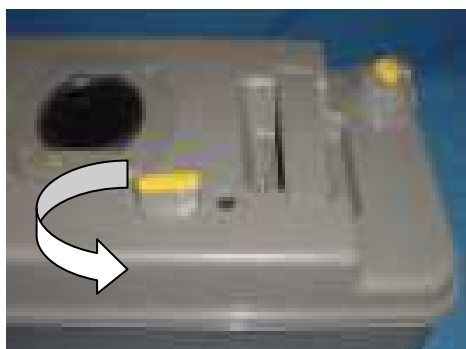
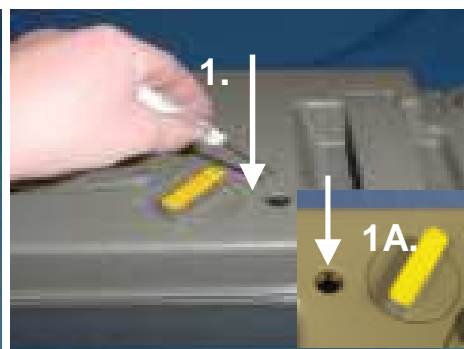
**A**

Open the blade, and depress the vent seal (1) around outer edge of seal (1a).

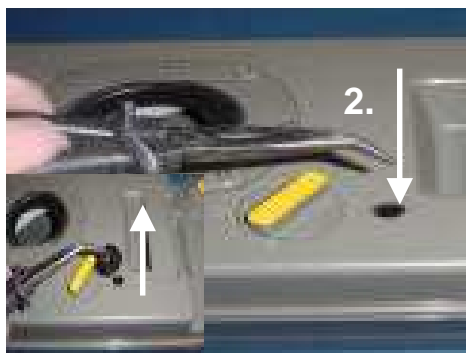
**B**

Take the vent seal out (2).

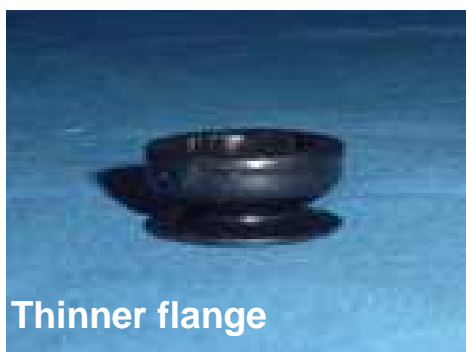
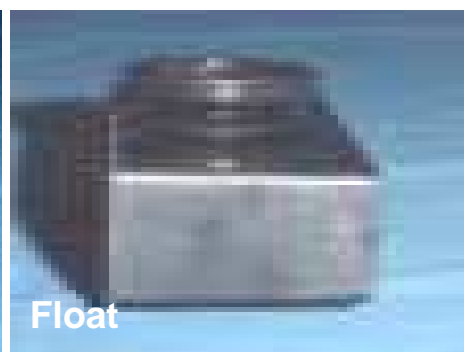
**C**

Bring new vent seal on its place as shown. Thinner flange has to be on the float which is inside the waste tank.

Thinner flange

Float

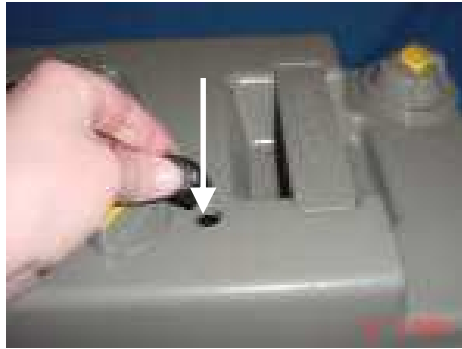
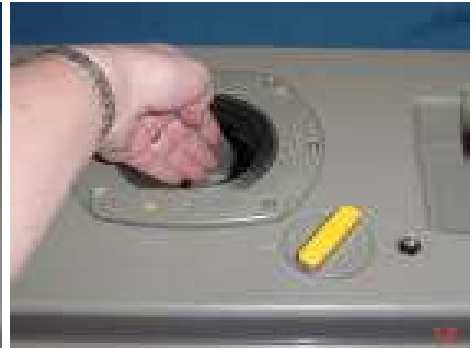
D

Depress the vent seal through the hole, from the outside. **Note:** Make sure that the vent seal is lying in the middle of the hole, when looking from the top.

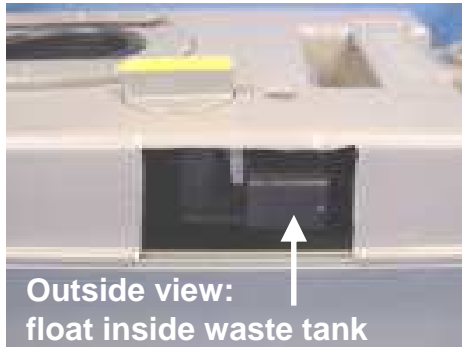
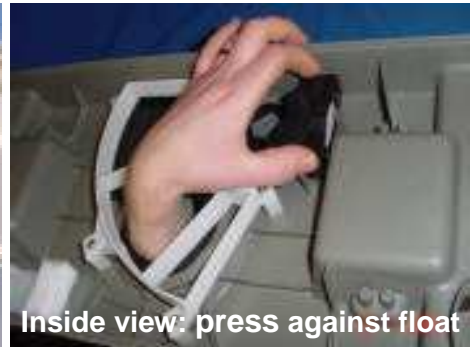
E

Go with your hand in the waste tank.

press against the float (vent seal will be pressed into its place).
